Manhole Inspection Summary

Manhole # S35G__033MH

Insp Date: **1/5/09 11:53 AM**

Location Address: **1 st paul st**

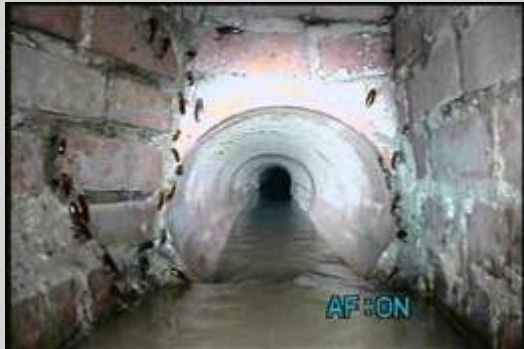
12 O'Clock Outflow

12 in. Circular Gravity Sewer
Pipe Out @ 12 O'Clock

Pipe Material: **Clay** ☐ Pipe Lined

Invert Depth: 10.10 (ft.) Flow Characteristics: **Slow**

Deposits: ☒ None ☐ Mud ☐ Sludge ☐ **Debris** ☐ Grease

Infiltration: **None** Pipe Seal Cond: **Unknown**

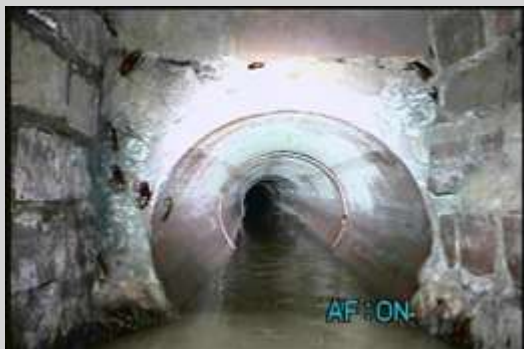
6 O'Clock Inflow

12 in. Circular Gravity Sewer
Pipe In @ 6 O'Clock

Pipe Material: **Clay** ☐ Pipe Lined

Infiltration: **None** Pipe Seal Cond: **Unknown**
